National Transportation Safety Board

RRD21MR017

VIDEO STUDY

Location: Joplin, Montana
Date: September 25, 2021
Time: 3:56 PM local time
Vehicle: Amtrak train 7 (Empire Builder)

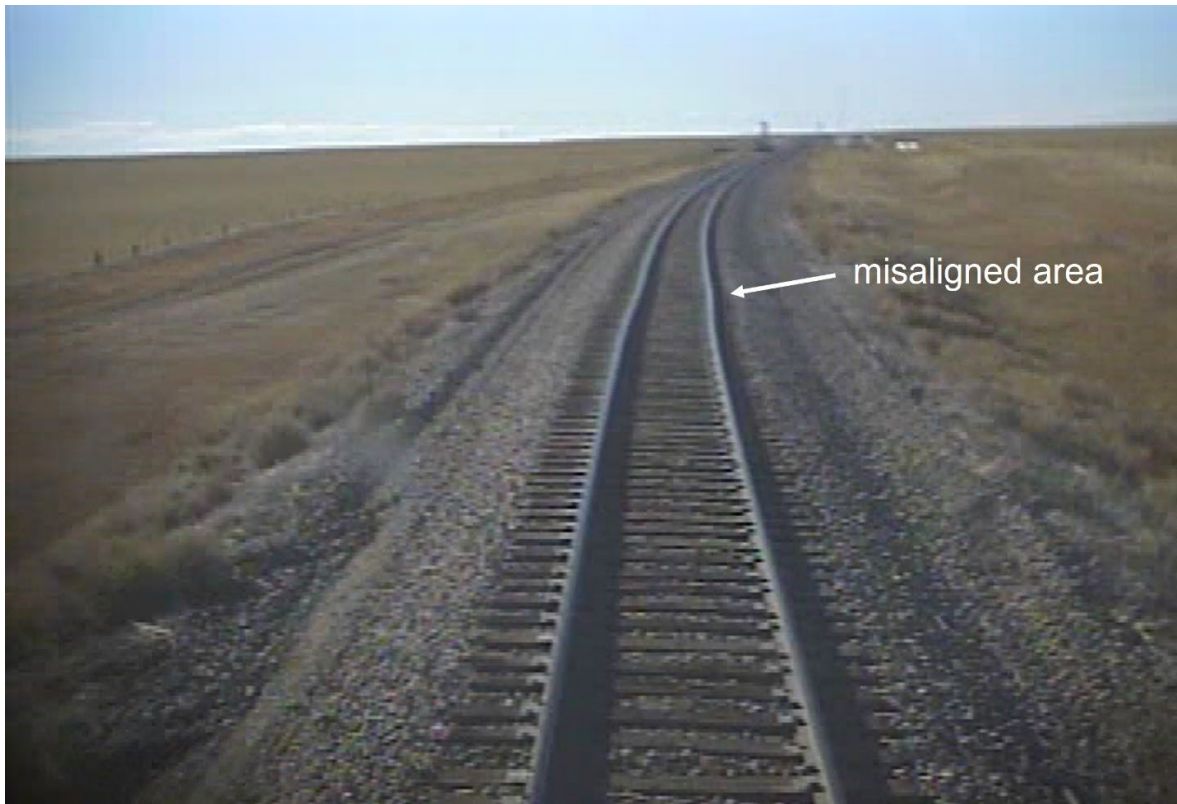
A camera mounted on the windshield of the lead locomotive of Amtrak train 7 recorded video that showed lateral deviations of rails ahead of the train. Figure 1

shows one frame from that video. This and other frames from the video were used to estimate the maximum lateral deviations of the rails from their original locations.

The rail profile at the derailment location was AREMA 132RE with 3.00" rail head width, 6.00" rail base width and 7.12" rail height. Since the sun was located left of the track, Figure 1 shows the shadows of the rails to the right of the rails. The most visible lateral locations on the rails were the boundaries between the rail heads and the shadows, i.e., the right edges of the rail heads. These edges were considered to be the locations of the rails in the analysis that follows.

Figure 1. Frame from Amtrak train 7 video that shows the misaligned rails

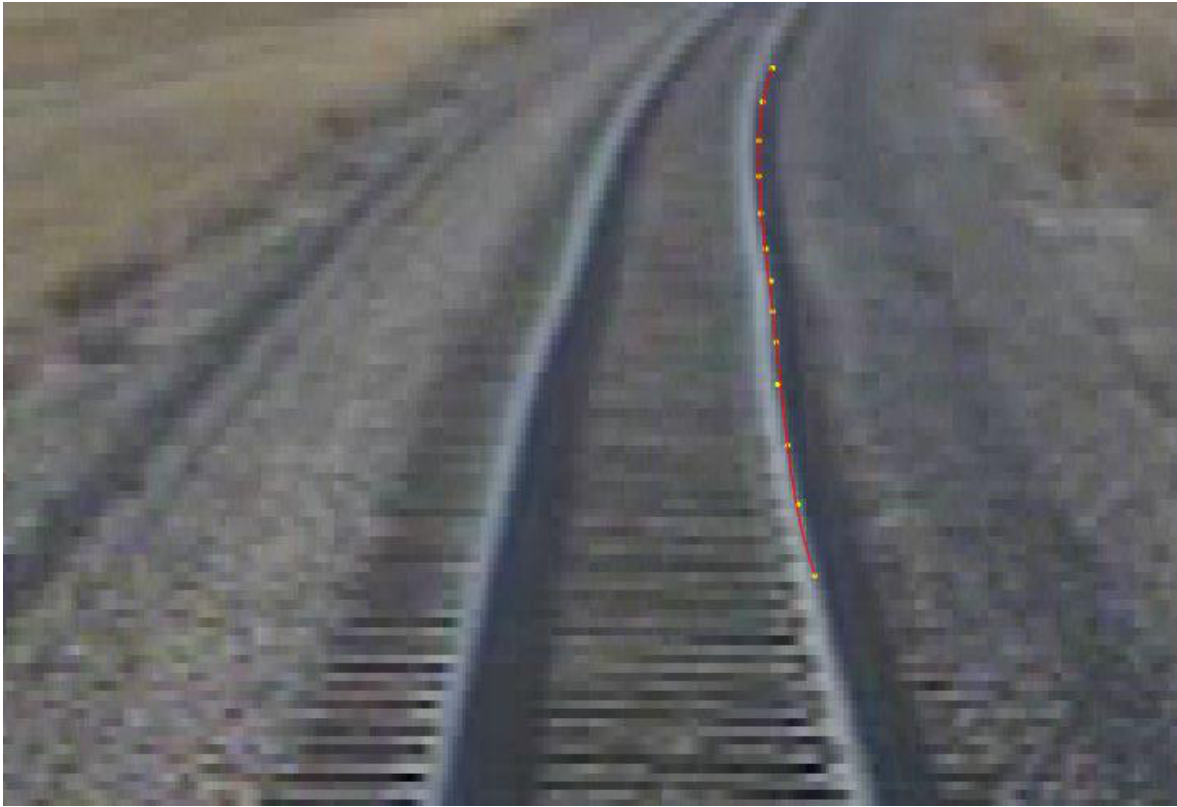
The same process was then used to fit a 5th order polynomial curve to the misaligned right rail seen in Figure 1. The higher order of the polynomial fit was required because the misaligned rail had a more complex shape than the reference rail. The fit is shown in Figure 3.

Figure 3. Polynomial fit to the misaligned right rail

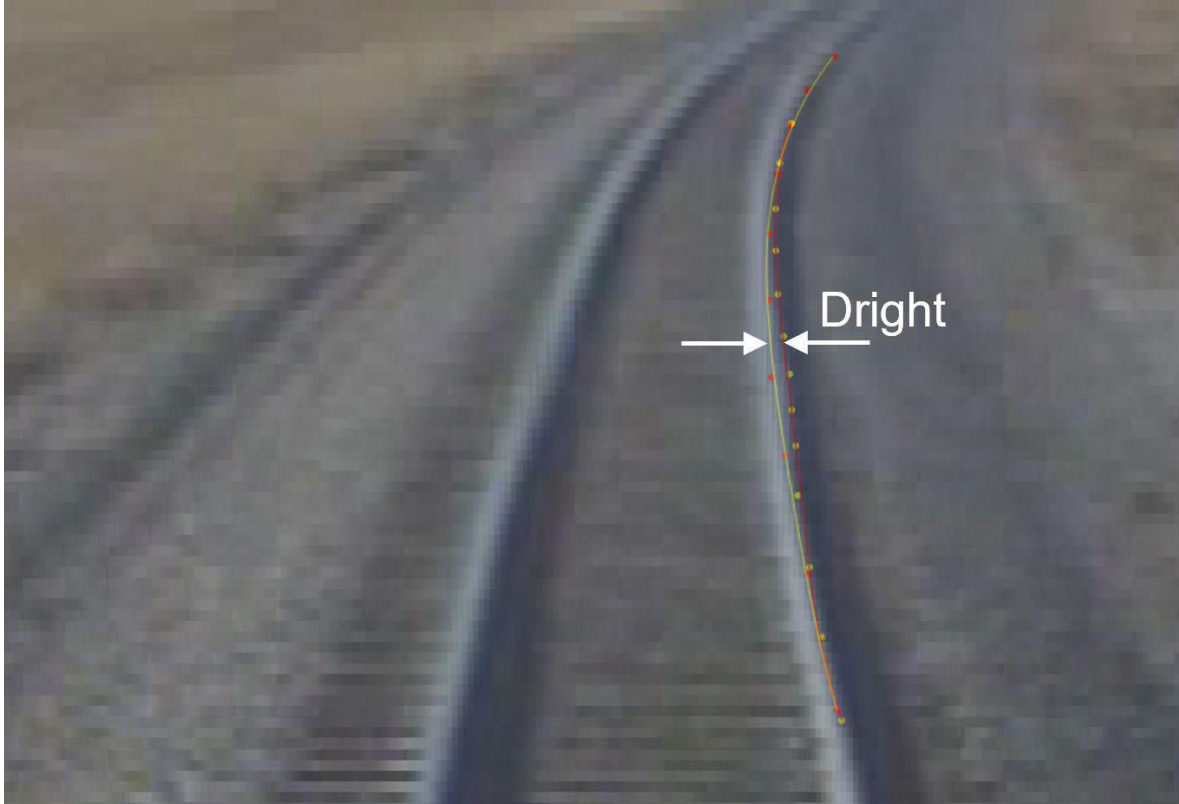
The video frame with the reference rail and the fitted polynomial curve was then placed on top of the video frame with the misaligned rail and its fitted polynomial curve. The reference video frame was assigned 50% transparency so that both tracks and both polynomial curves were visible. Figure 4 shows the image of the zoomed superimposed video frames. The yellow curve is the fit to the reference rail that is based on the red data points. The red curve is the fit to the misaligned right rail that is based on the yellow data points. The maximum deviation of the misaligned right rail relative to its reference shape is marked as Δ right in the figure.

Additionally, each vertical pixel in Figure 1 represents about 20 inches of rail length at the location of maximum rail deviation. Figure 4 shows that the deviation is near its maximum value along about 20 feet of track. These 20 feet of track correspond to about $20 \times 12 / 20 = 12$ pixels heights (i.e., the vertical dimensions of the pixels) in Figure 4. If the lateral distance between the reference rail and the misaligned rail was being measured along only one horizontal line of pixels, the error could be as large as ± 1.4 inches. However, analysis shows that the distance between the reference rail and

The two reasons why the rail deviation estimation error is smaller than the maximum ± 1.4 inches were explained above. Therefore, an estimate that is more realistic than the most conservative estimate is that the maximum rail deviations are between 2.6 ± 0.7 inches and 3.2 ± 0.7 inches, or, when combined, 2.9 ± 1.0 inches.

Figure 4. Measurement of the right rail misalignment

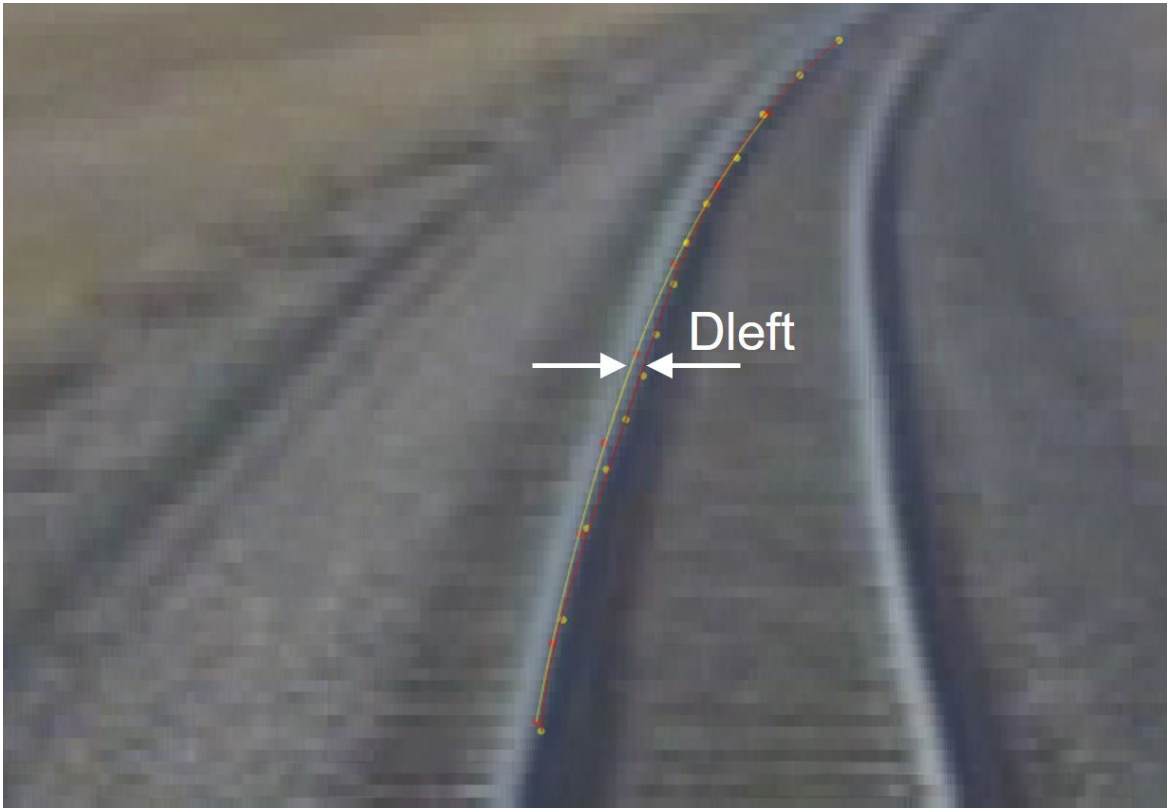
The same process was repeated for the left rail. Figure 5 shows the image of the zoomed superimposed video frames. The yellow curve is the fit to the reference rail that is based on the red data points. The red curve is the fit to the misaligned left rail

that is based on the yellow data points. The maximum deviation of the misaligned left rail relative to its reference shape is marked as Dleft in the figure.

Figure 5. Measurement of the left rail misalignment

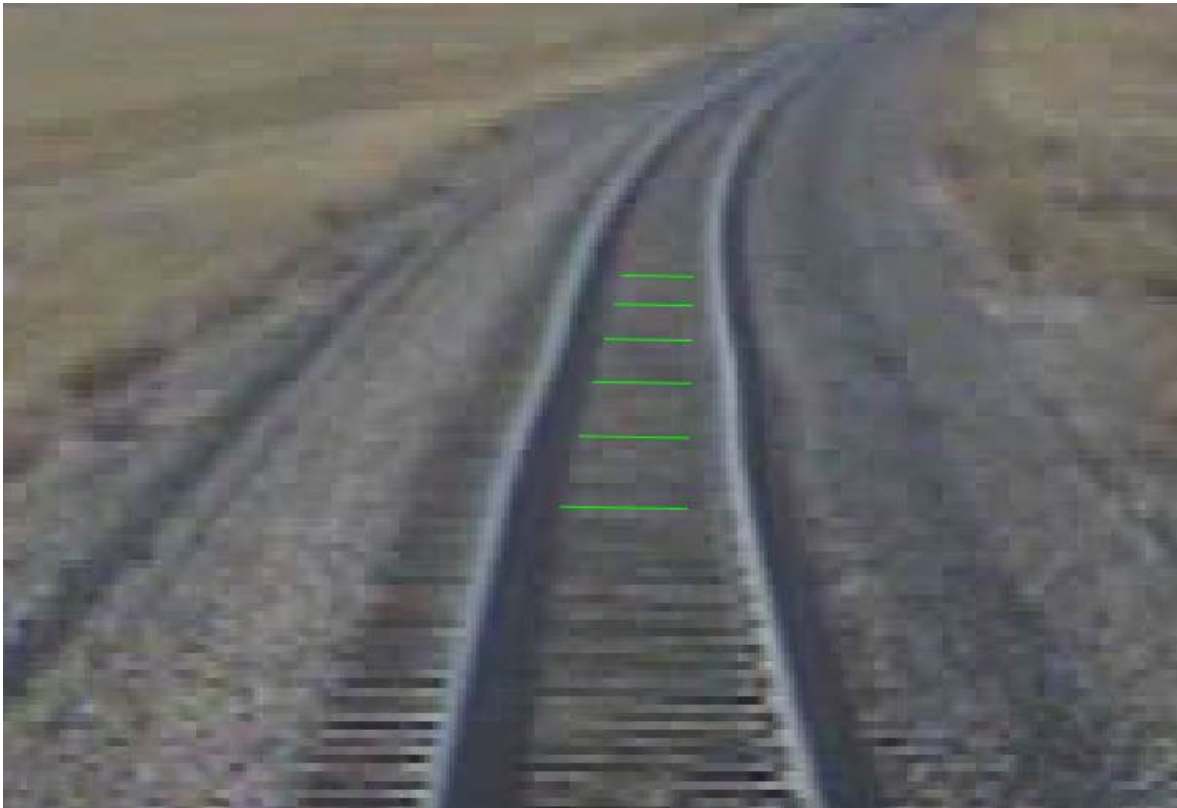
Figure 6 shows a zoomed detail from the video frame in Figure 1 with superimposed green lines spaced by 20 feet from each other. The figure shows that the track section that was significantly misaligned to the right from its original location is about 40 feet long. If even minor rail misalignments are considered, the misaligned section was about 60 feet long. If it is assumed that the misalignment follows a curve consistent with a theoretical buckling model, the shape of the 60-foot misaligned rail segment can be approximated by a cosine wave.

Figure 6. Misaligned track section with markers spaced by 20 feet

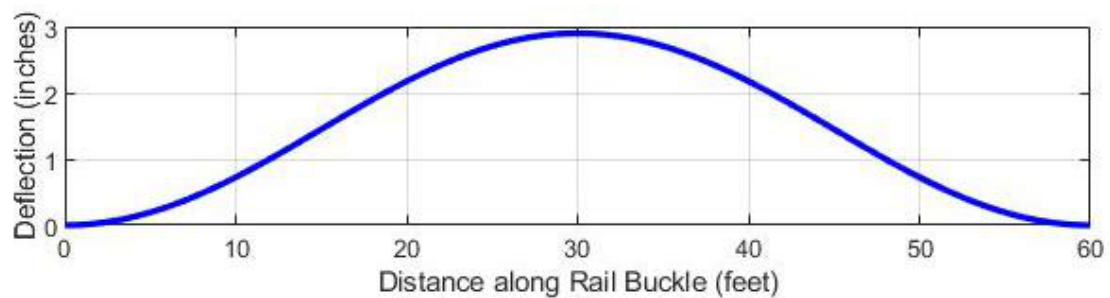
Figure 7 is a plot of the rail misalignment as specified in Equation (1) for $L=60$ feet and $D=2.9$ inches. As can be appreciated from Figure 6, the video does not have the resolution that would allow accurate measurement of the misalignment along the 60-feet-long rail segment. Figure 7 is the assumed theoretical shape of a 60-feet-long buckled beam with clamped ends when the deflection in its center is 2.9 inches. This shape can be used as an approximation of the actual shape in dynamic simulations of rail vehicles moving across the misaligned track section in this accident.

Figure 7. Theoretical shape of a misaligned rail section

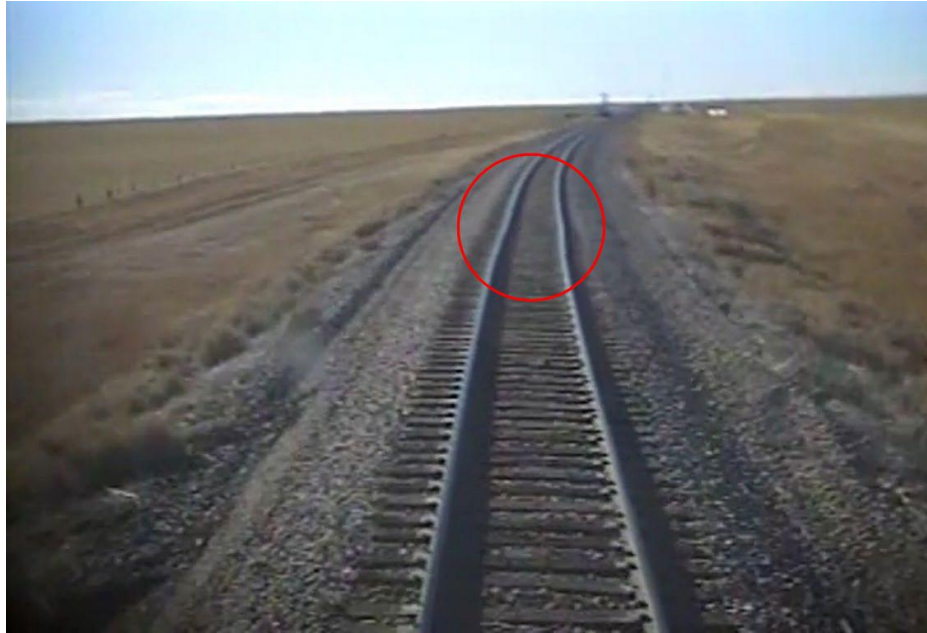
The videos from the other six trains that passed the derailment location earlier did not show measurable lateral rail deviations. Rail deviations of 1 inch or less are not measurable, given the uncertainty in the method of analyzing the videos. Figure 8 shows the track segment with the measurable lateral rail deviations in the Amtrak train 7 video. Figure 9 shows the same track area in the Amtrak train 135 video where the deviations are not measurable. Figure 10 shows the track segment with the measurable lateral rail deviations in the BNSF7380 train video. Figure 11 shows the same track area in the BNSF4182 train video where the deviations are not measurable. The BNSF4182 train passed that location 12 minutes before the BNSF7380 train.

Figure 8. Rail misalignment location - Amtrak train 7 video

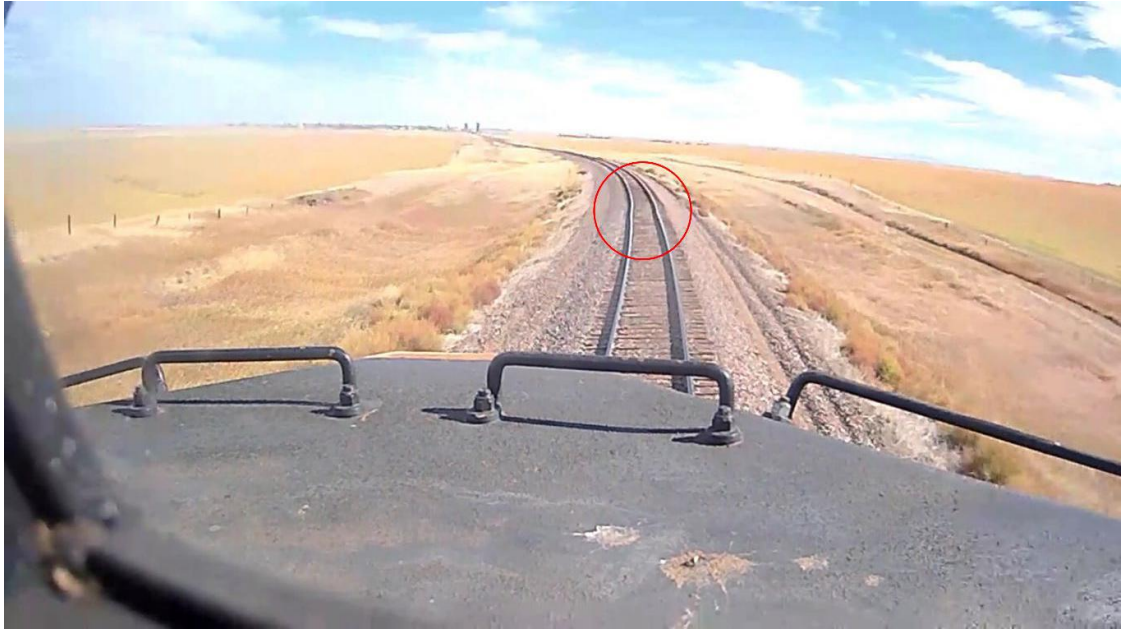
addition to Amtrak train 7, only the BNSF7380 train video showed measurable lateral rail deviations. It passed the derailment location about two hours and fourteen minutes before Amtrak train 7. The rail deviation size estimated based on the BNSF7380 train video was the same as that estimated based on the Amtrak train 7 video, 2.9 ± 1.0 inches.

Figure 10. Rail misalignment location - BNSF7380 train video

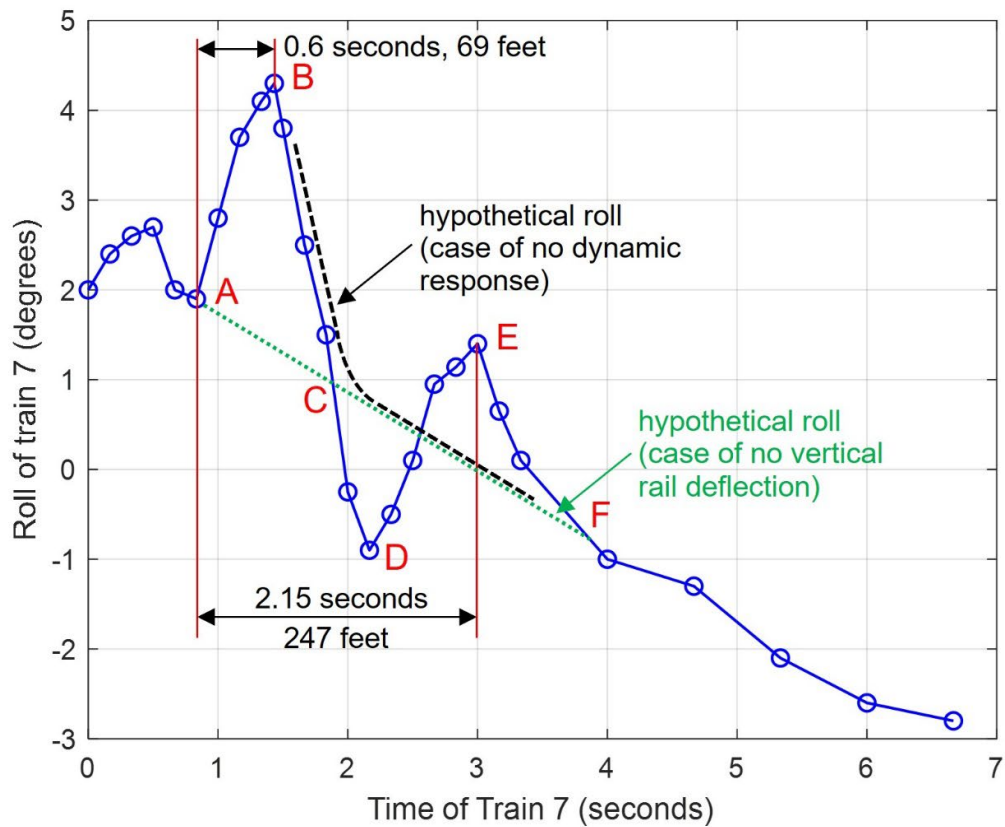
Figure 13 is a plot of the measured Amtrak train 7 camera roll angle. The figure shows a roll transient lasting about 3.15 seconds between about time 0.85 seconds (point A), when the transient started, and time 4 seconds (point F) when the transient was over. During the 0.6 seconds marked in the figure, the roll angle increased by about 2.4° and reached a local maximum value of 4.2°. It is estimated that the 69 feet that the train traveled during this period is related to the length of the deflected rail segment, possibly being half of it, or all of it, or a fraction between half and all of it.

Assuming a rail gauge of 56.5 inches, a locomotive roll angle increase by 2.4° is caused by the right rail deflecting vertically by $56.5 \times \tan(2.4^\circ) = 2.4$ inches. It is estimated that in the absence of the vertical rail clearance and the absence of the transient it caused, the roll curve section showing the transient in Figure 13 would have looked like the hypothetical roll represented by the dotted green line.

If the response to the vertical rail clearance was static, the roll response would have ended at about point C, where the vertical clearance ended, and the roll angle curve would have looked like the black broken-line curve in the figure. But it was not so. Point B is at the maximum positive (right-side-down) roll angle of 4.2°. At about time 2.1 seconds, the roll angle peaked at a left-side-down roll angle of about -0.9° and at time 3 seconds it again peaked at a right-side-down roll angle of about 1.4°.

The three local peaks of the locomotive roll response point to a dynamic response where the locomotive roll, yaw and lateral motions were coupled with the lateral and yaw motions of the trucks and the wheelsets. This resulted in a dynamic transient that lasted beyond the section of the vertical rail clearance. The coupling between the locomotive body motions and the motions of the locomotive wheelsets probably resulted in lateral wheel flange to rail impacts. When Amtrak train 7 was at the derailment location, the lateral rail deviations were already present. It is estimated

Figure 13. Measured roll angle of Amtrak train 7 (westbound)

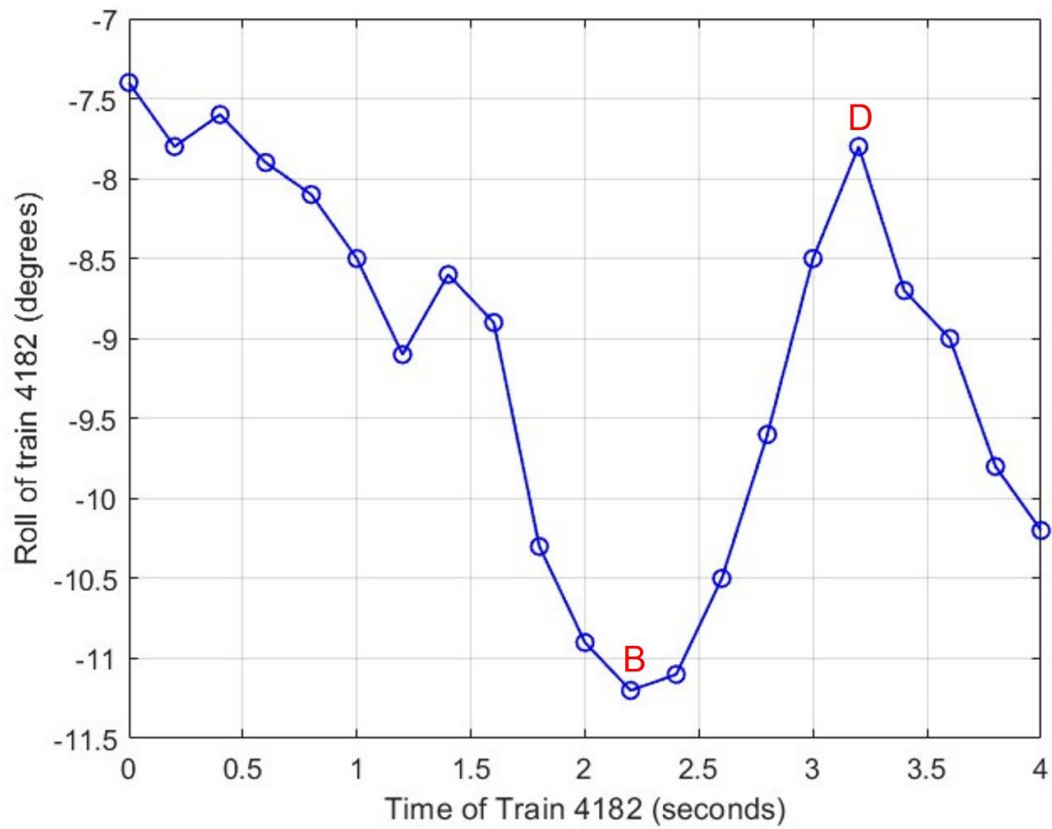
Table 1 indicates that the measurable lateral rail deviation appeared after the BNSF4182 train passed the vertical deflection area. Figure 19 shows the roll angle of BNSF4182. Points B and D marked in Figure 19 are the first two peaks of the transient roll response. They are analogous to points B and D of Amtrak train 7 in Figure 13, but their polarity is reversed because Amtrak train 7 was moving west and BNSF4182 was moving east. The presence of peak D in Figure 19 indicates that the locomotive of BNSF4182 experienced a dynamic transient similar to the dynamic transient that the Amtrak train 7 locomotive experienced. This opens the possibility that the lateral wheel flange to rail impacts of the BNSF4182 locomotive and rail cars contributed to the development of the measurable lateral deviation of the rails that appeared after BNSF4182 passed the location of the vertical clearance.

Figure 19. Measured roll angle of BNSF4182 train (eastbound)
